Draft Final Report • National Institute of Standards and Technology (NIST)

of the May 22, 2011,
Tornado in
Joplin, Missouri

NIST NCSTAR 3 (Draft)

November 2013

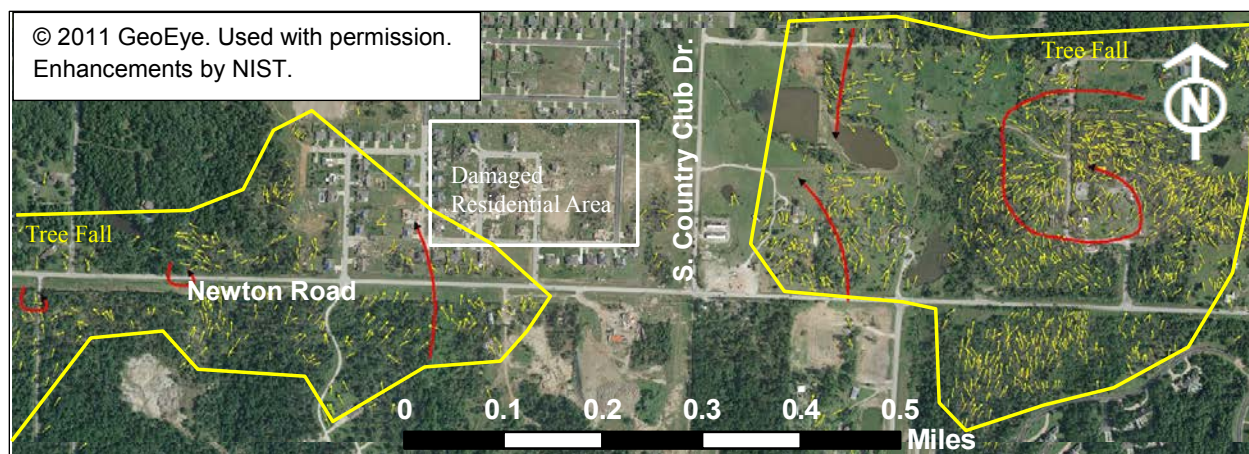
Figure 1–4. Initial damage in the Joplin tornado. Yellow arrows indicate directions of treefall. Possible multiple vortices shown by red arrows.

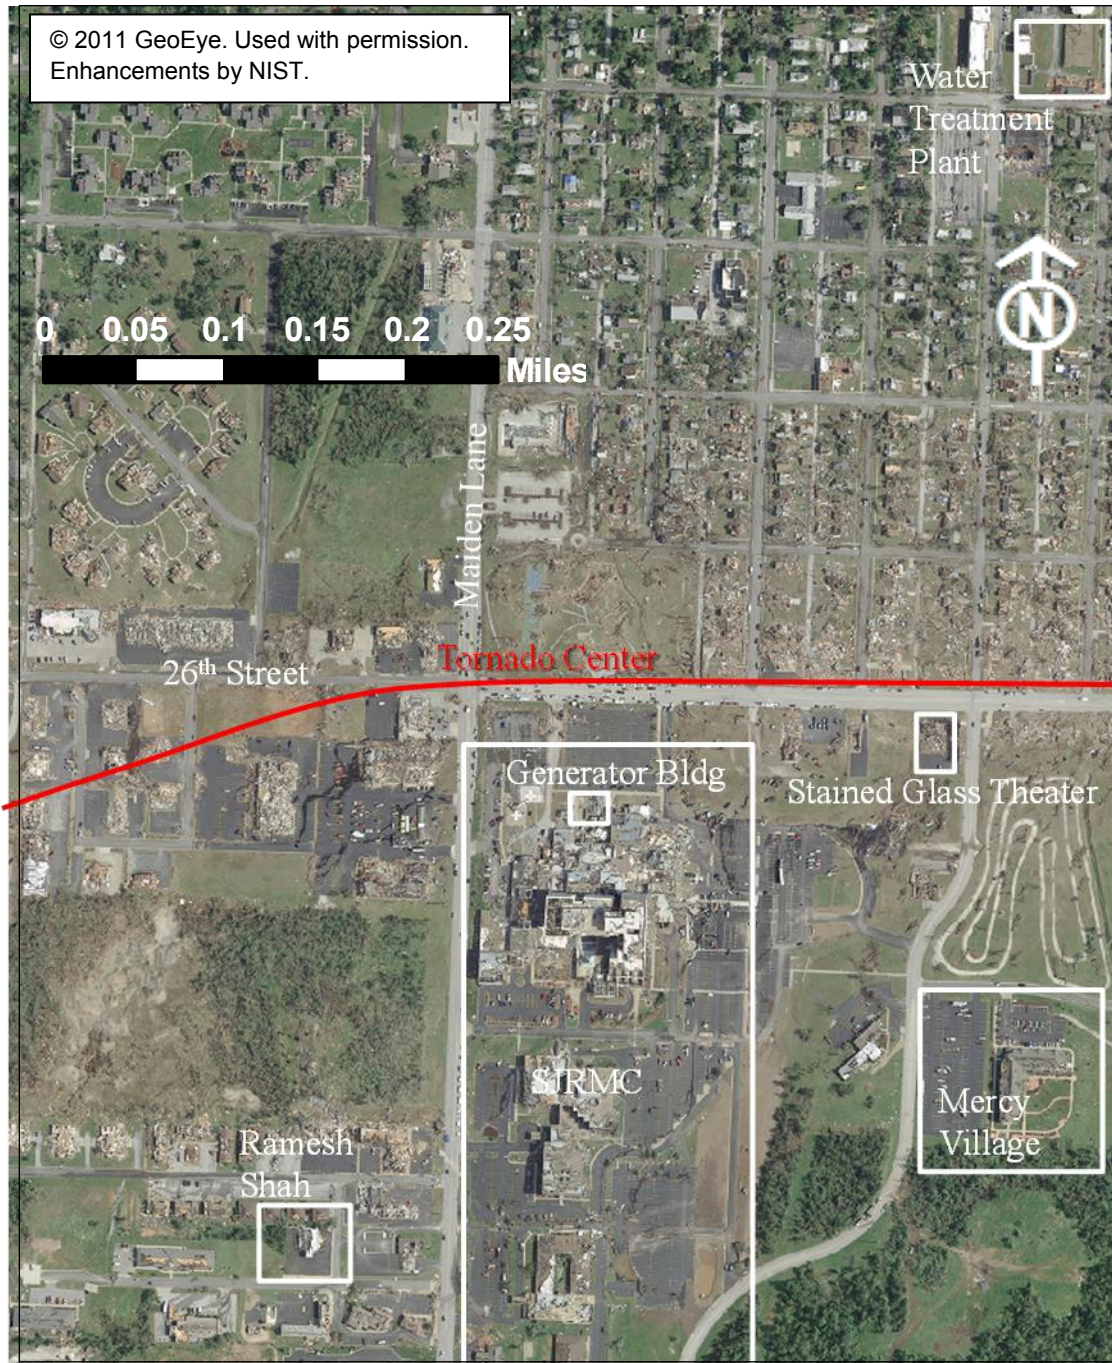
Tornadoes that strike populated areas leave a number of indicators of their strength in addition to damaged and destroyed buildings. Just outside the two SJRMC towers, concrete parking bumpers in the parking lot were pulled up from the ground, parking signs were flattened, and cars were thrown into the air. In other locations, steel manhole covers and tractor-trailers were tossed around by the storm. However, determining the wind speeds required to do such damage is an inexact science.

Figure 1-6 . Aerial photo showing damage to SJRMC and the surrounding area.

A total of 14 lives were lost at SJRMC as a result of the tornado. Due to the significant damage sustained by all of the buildings, Mercy, the parent organization of SJRMC, decided to raze the entire facility beginning in January 2012. This represented an insured loss estimated at \$600 million.³⁵

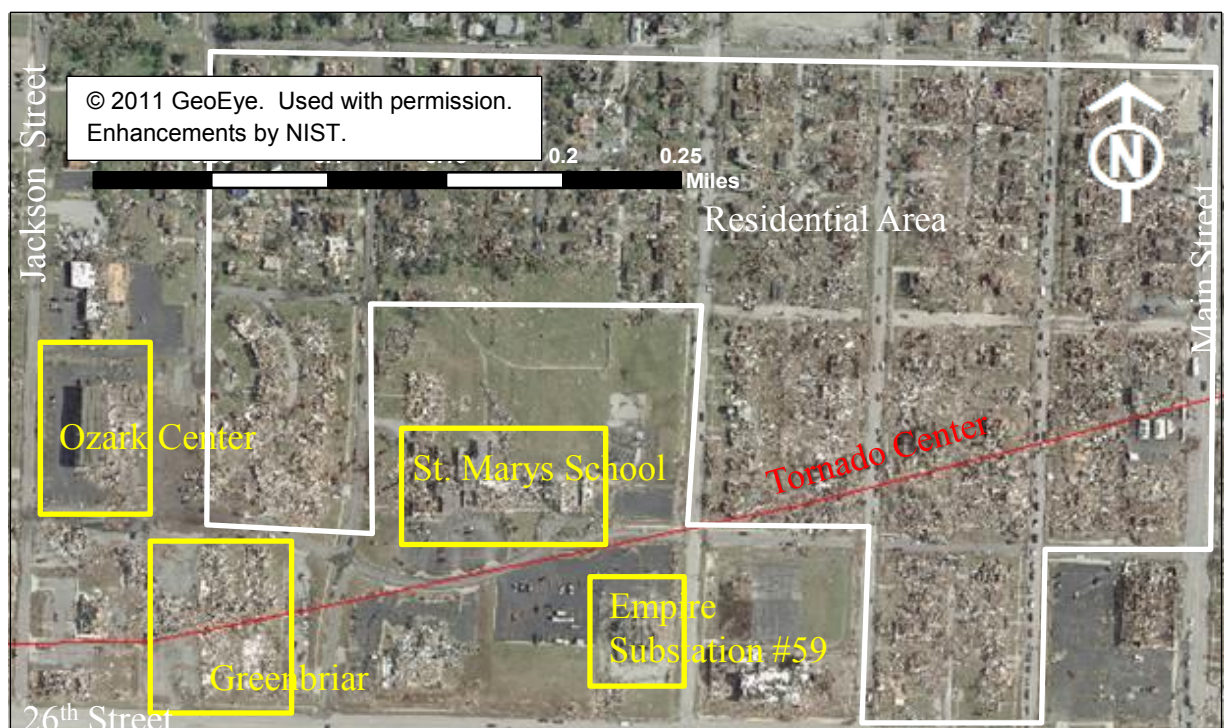
Figure 1–7. Aerial photo showing locations of the Ozark Center for Autism, Greenbriar Nursing Home, St. Mary’s Catholic Elementary School, and EDE substation 59 (from west to east). Residential area is outlined in white.

Empire District Electric (EDE) substation 59 was located adjacent to St. Mary’s School and in close proximity to the tornado center line. This steel-framed substation, which delivered electrical power to residences and businesses in the vicinity, including SJRMC, was completely destroyed. It was one of six power substations impacted by the event. The destruction of this substation and the extensive damage to other electrical transmission and distribution systems resulted in a loss of power to more than 20,000 EDE customers located inside and outside of the tornado-damaged area. The tornado also wreaked havoc on water and gas distribution systems. It caused thousands of small leaks in residential and fire water-service lines and a subsequent sharp drop in water pressure in the area. Additionally, there was extensive damage to gas mains and meters, which resulted in numerous gas leaks in the affected area.

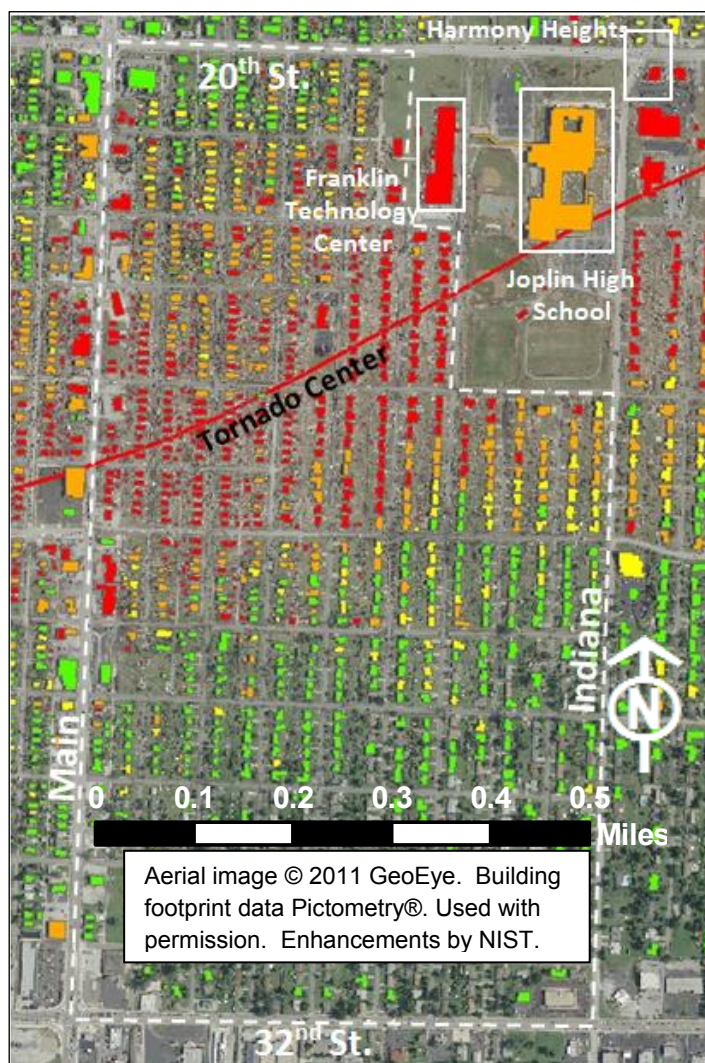
Figure 1–8. Aerial photo showing the locations of a heavily damaged residential area, Franklin Technology Center, Joplin High School, and Harmony Heights Baptist Church. The color of each building footprint shows the level of damage to that structure.

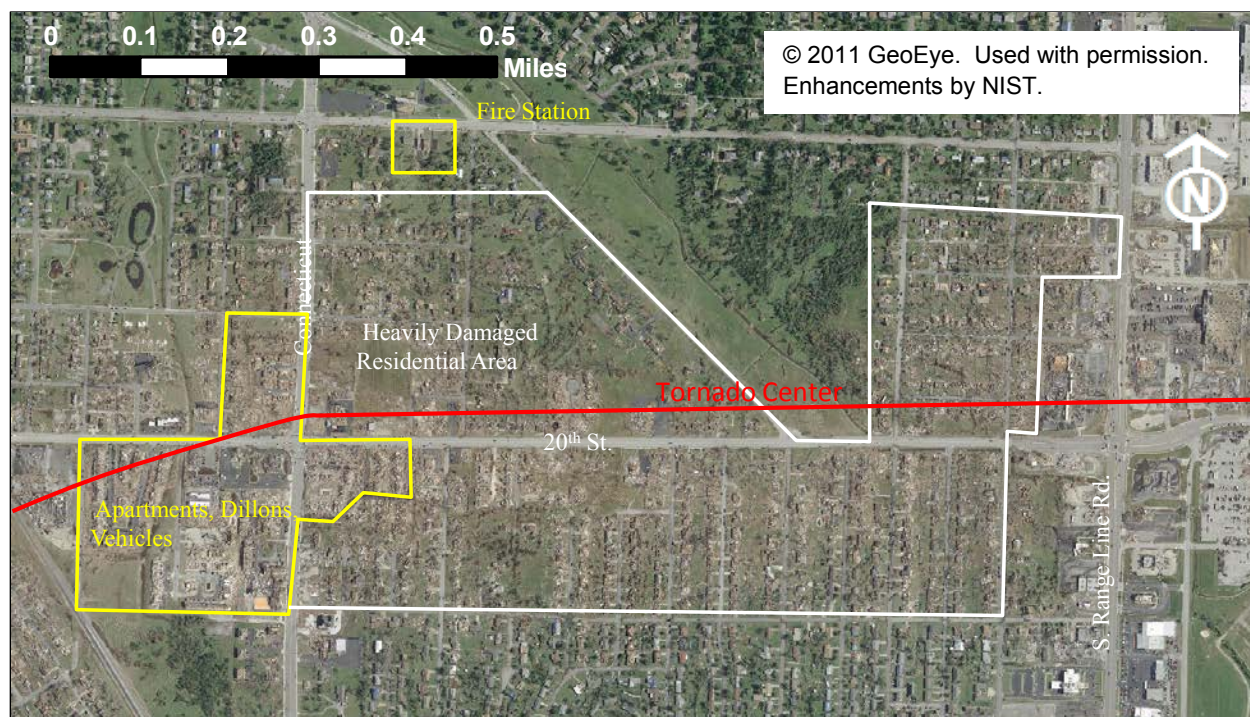
Figure 1–9. Aerial photo of damaged residential areas (including apartment complexes) in Joplin near the intersection of 20th and Connecticut.

residential area to the north and south of 20th Street. Six fatalities occurred in homes within this area, which is outlined in Fig. 1–9.

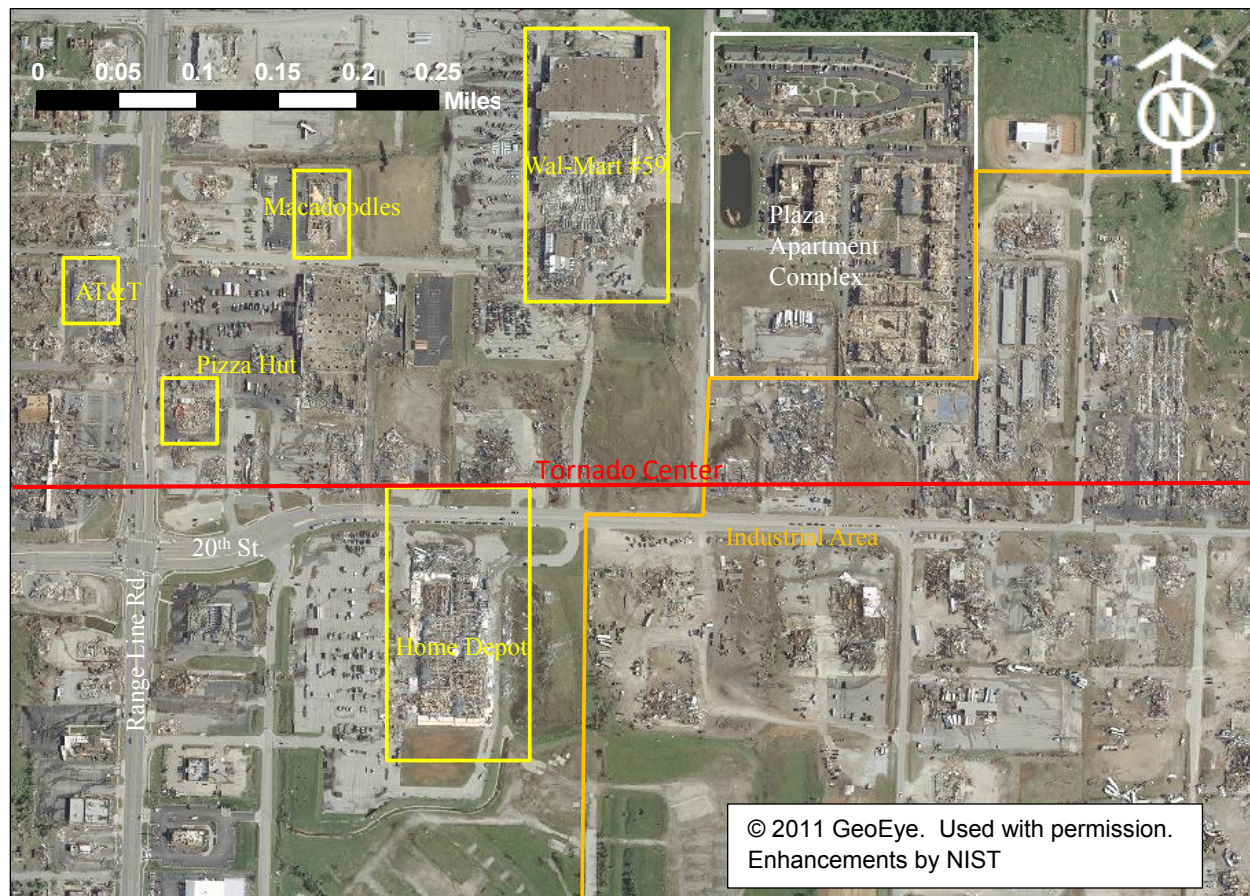
Figure 1–10. Aerial photo showing damage to a commercial area on the eastern side of Joplin near the intersection of Range Line Road and 20th Street.

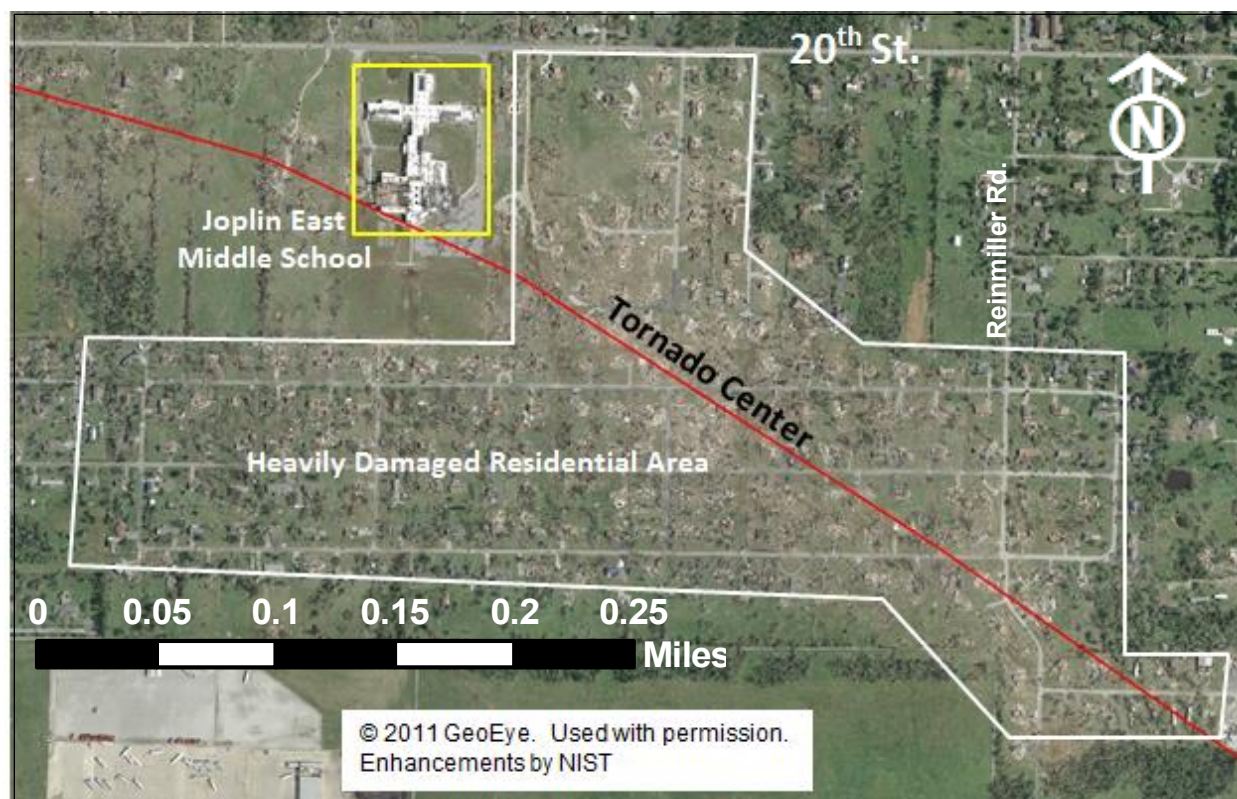
Figure 1–11. Aerial photo of damage to a residential area and Joplin East Middle School.

the area as the winds strengthened. Video footage of the gymnasium, on the south side of the school, showed ceiling lights swaying and bits of roofing material, including panels of metal roof decking, falling onto the gym floor as the winds began to increase. Later footage showed that failed roof trusses had fallen onto the gym floor and the western wall of the gymnasium had collapsed toward the interior of the building.

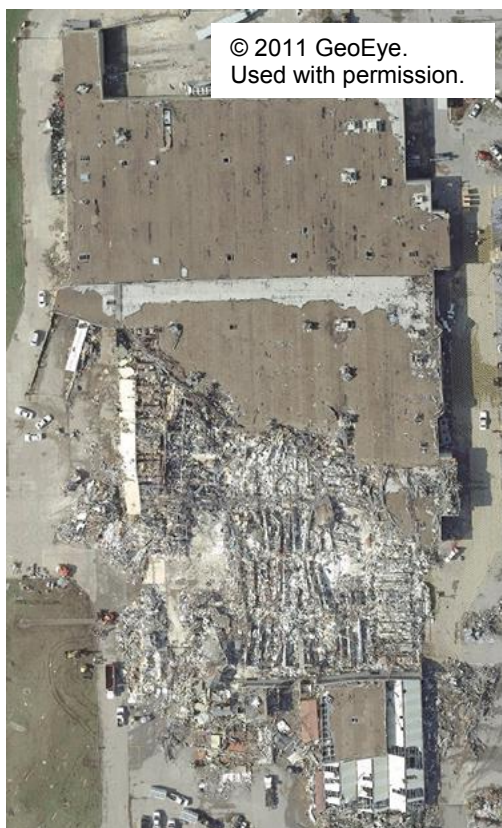
One example that demonstrates the challenges in assigning definitive DODs for large structures involves the Walmart (Store #59) located at 1501 South Range Line Road in Joplin. This large building was 573 feet (175 meters) long, oriented along a north–south axis. The building was located north of the center line of the tornado track. The southern part of the building, which was closer to the center of the tornado, suffered extensive damage, while the northern part of the building experienced much less damage as shown by the aerial photo in Fig. 2–13.

Figure 2–13. Aerial photo of Walmart Store #59 showing extensive damage to the southern (bottom) half of the building.

Under the EF scale guidance, this type of building is classified as DI 12, a “Large, Isolated Retail Building.” However, which DOD should be selected is less than clear. The structure could fall into either DOD 6, “inward or outward collapse of exterior walls,” which occurred in the southern half of the building, or DOD 7, “complete destruction of all or large sections of the building,” which could apply based on Figure 2–13. However a ground level picture (Fig. 2–14), reveals that some of the southern portion of the structure remained in place and suggests a DOD less than 7. The expected wind speeds (and lower/upper bounds) for DOD 6 and DOD 7 for DI 12 are 118 mph (98/158) and 147 mph (110/201), respectively. Consequently, assigning a specific DOD and an associated wind speed becomes somewhat subjective. Since the damage to the Walmart clearly exceeded DOD 6 and didn’t quite meet DOD 7 for a portion of the building, a point estimate of 140 mph \pm 15 mph was assigned. This made the estimated lower bound 125 mph, a value that could still account for DOD 6 while falling within the bounds of DOD 7. The upper bound, 155 mph, still falls within the range of DOD 6 wind speeds, and sits squarely within the wind speed range associated with DOD 7.

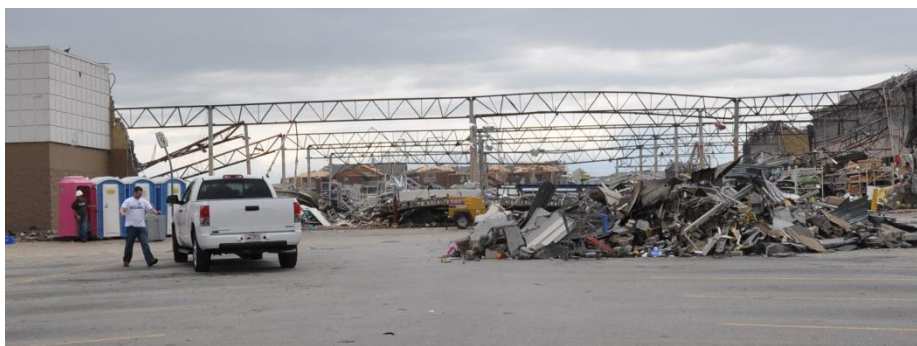
Figure 2–14. Elevation view of southwest-facing wall of Walmart Store #59.

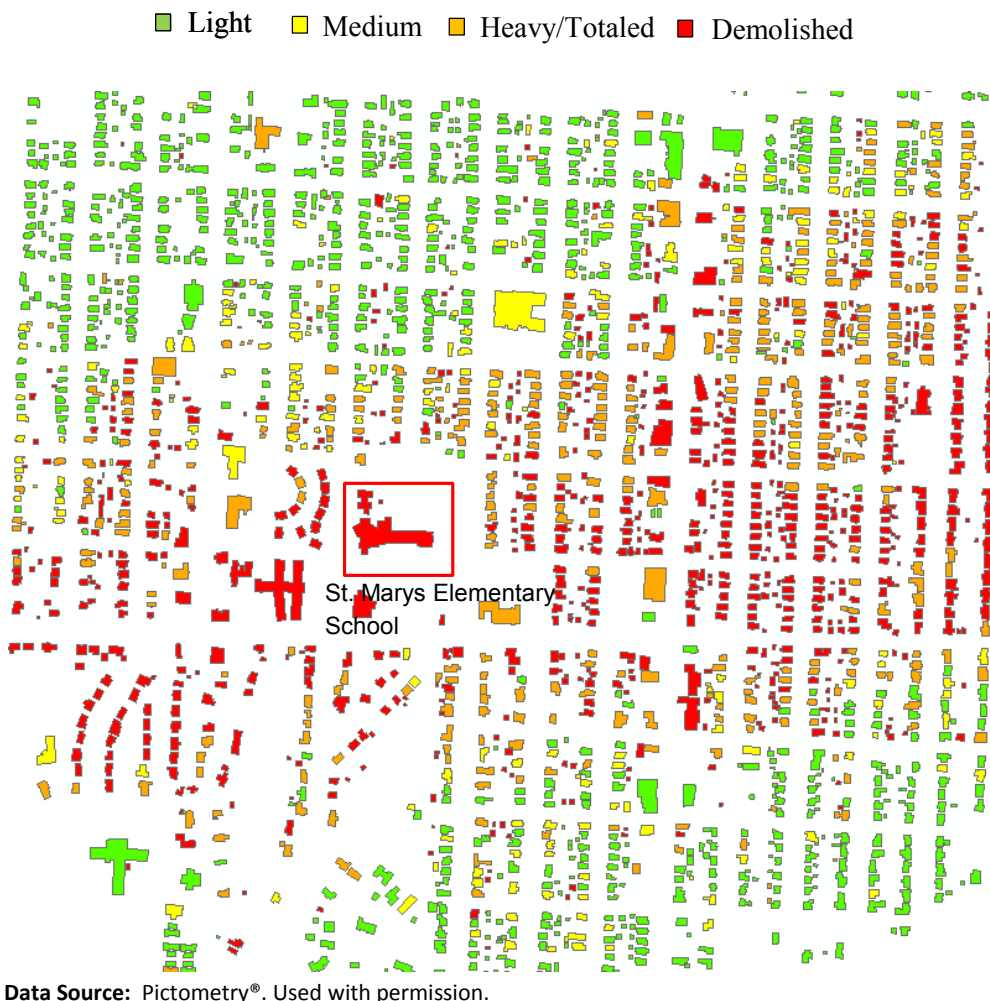
demolished). These damage classes were estimated by analyzing the differences between pre- and post-storm aerial imagery (orthorectified and oblique) of the Joplin area.⁴⁷ The damage classes estimated for building footprints in part of Joplin are shown in Fig. 2–15. The numbers of structures assigned to each class citywide are listed in the last row of Table 2–3. Wind speed statistics and numbers of structures estimated for residential damage levels using EF Scale.

To correlate the damage classes with the EF Scale, 10 structures within each damage class were randomly selected and assigned an EF rating using the EF Scale process. The 10 structures in each damage class were assumed to be representative of the entire population of structures within each class. The summary statistics for each damage class are shown in Table 2–3, along with an EF number corresponding with the average wind speed within each class. As expected, as the damage classes increase in intensity, the estimated wind speeds (and EF numbers) increase as well. The mean wind speeds for the damage classes were as follows: 78 mph (EF–0) for “light,” 93 mph (EF–1) for “medium,” 117 mph (EF–2) for “heavy/totaled,” and 144 mph (EF–3) for “demolished.”

Figure 2–15. Building footprints in part of Joplin showing damage classes. St. Mary's Catholic Elementary School (red box) shown for reference. Area shown is approximately 1.0 miles west to east and 0.8 miles north to south.

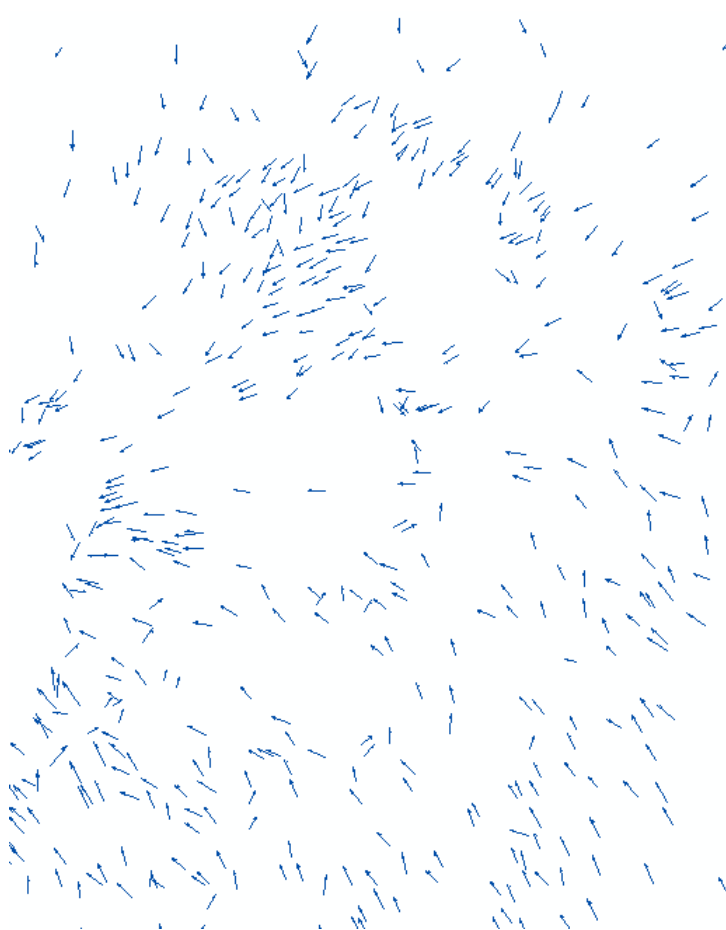
The directions of tree fall for approximately 5,000 felled trees throughout the tornado path were drawn digitally using post-storm aerial photos. Figure 2–18 shows the tree fall patterns observed between 20th and 32nd streets just east of Schifferdecker Avenue. A non-exhaustive list of the types of trees that fell in the Joplin tornado, as determined by field surveys, aerial photos, and interview transcripts, is as follows: American and Chinese elm, American sycamore, yellow poplar, shagbark hickory, white oak, and Bradford pear.

Figure 2–18. Observed tree fall pattern between 20th and 32nd streets just east of Schifferdecker Ave. Area is approximately 0.5 miles west to east by 1.0 miles north to south.

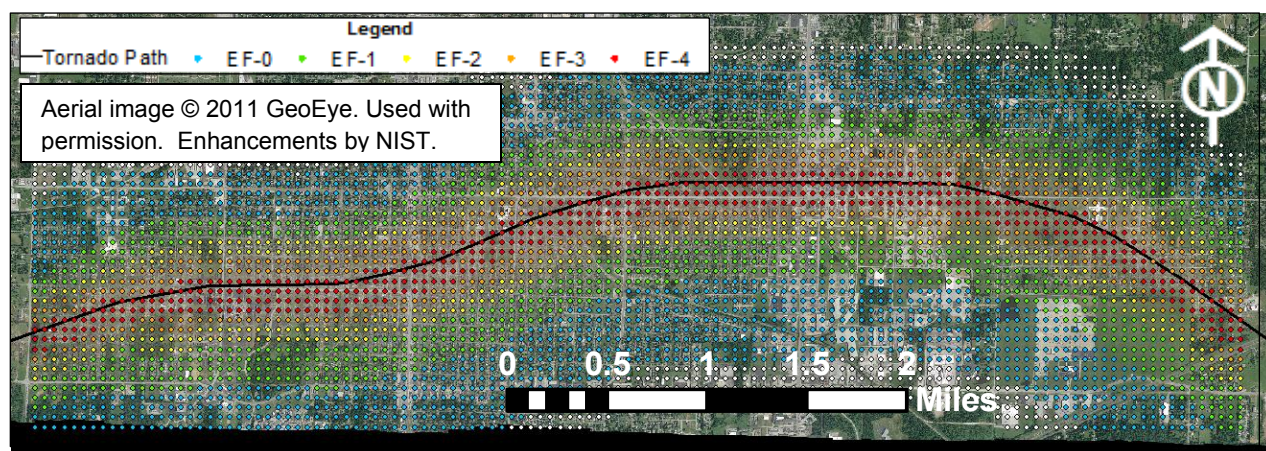
From the maximum wind speed information, two shapefiles were created in ArcGIS. The first shapefile shows the grid points in the wind field estimation colored by their best estimated maximum wind speed value. This wind field estimation is illustrated in Fig. 2–23. The coloration is based on wind speed ranges outlined in the EF Scale. The second shapefile was created by drawing polygons around areas that were within the wind speed ranges prescribed by the EF Scale. These polygons are shown in Fig. 2–24.

Figure 2–23. Estimated maximum wind speed grid points from tornado wind field model grid points grouped by EF Scale. The solid black line represents the estimated tornado center. The area in the figure is approximately 6.2 miles west to east and 2.0 miles north to south.

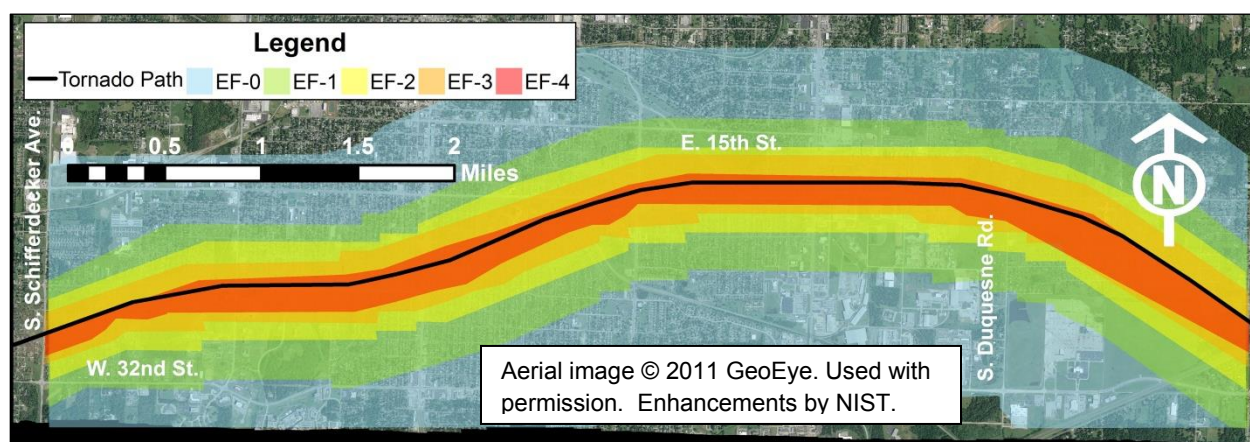
Figure 2–24. Estimated maximum wind speed polygons from tornado wind field model grouped by EF Scale. The solid black line represents the estimated tornado center. The area in the figure is approximately 6.2 miles west to east and 2.0 miles north to south.

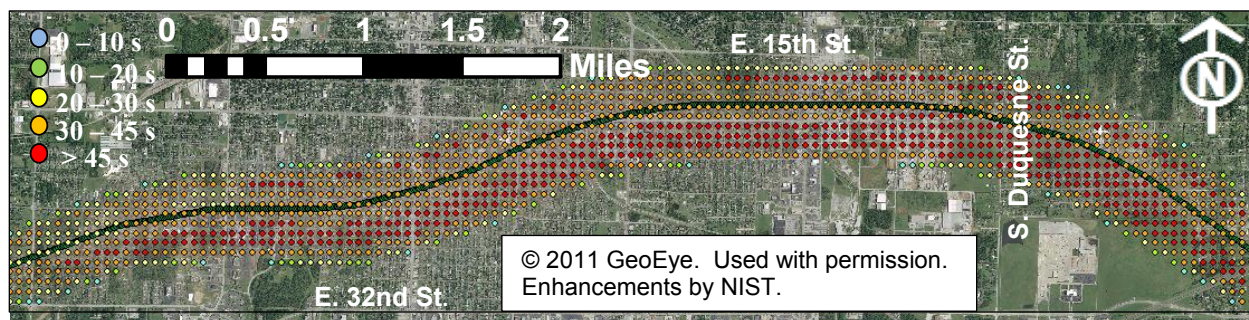
Figure 2–26. Best estimate of duration of wind speeds greater than or equal to EF–2 (≥ 110 mph). Green line shows estimated tornado center. The area in the figure is approximately 6.2 miles west to east and 2.0 miles north to south.

wind speeds was mainly south of the estimated tornado center shown in Fig. 2–26. The majority of areas that experienced any EF–2 or greater wind speeds encountered over 30 seconds of such winds due to the structure of the wind field.

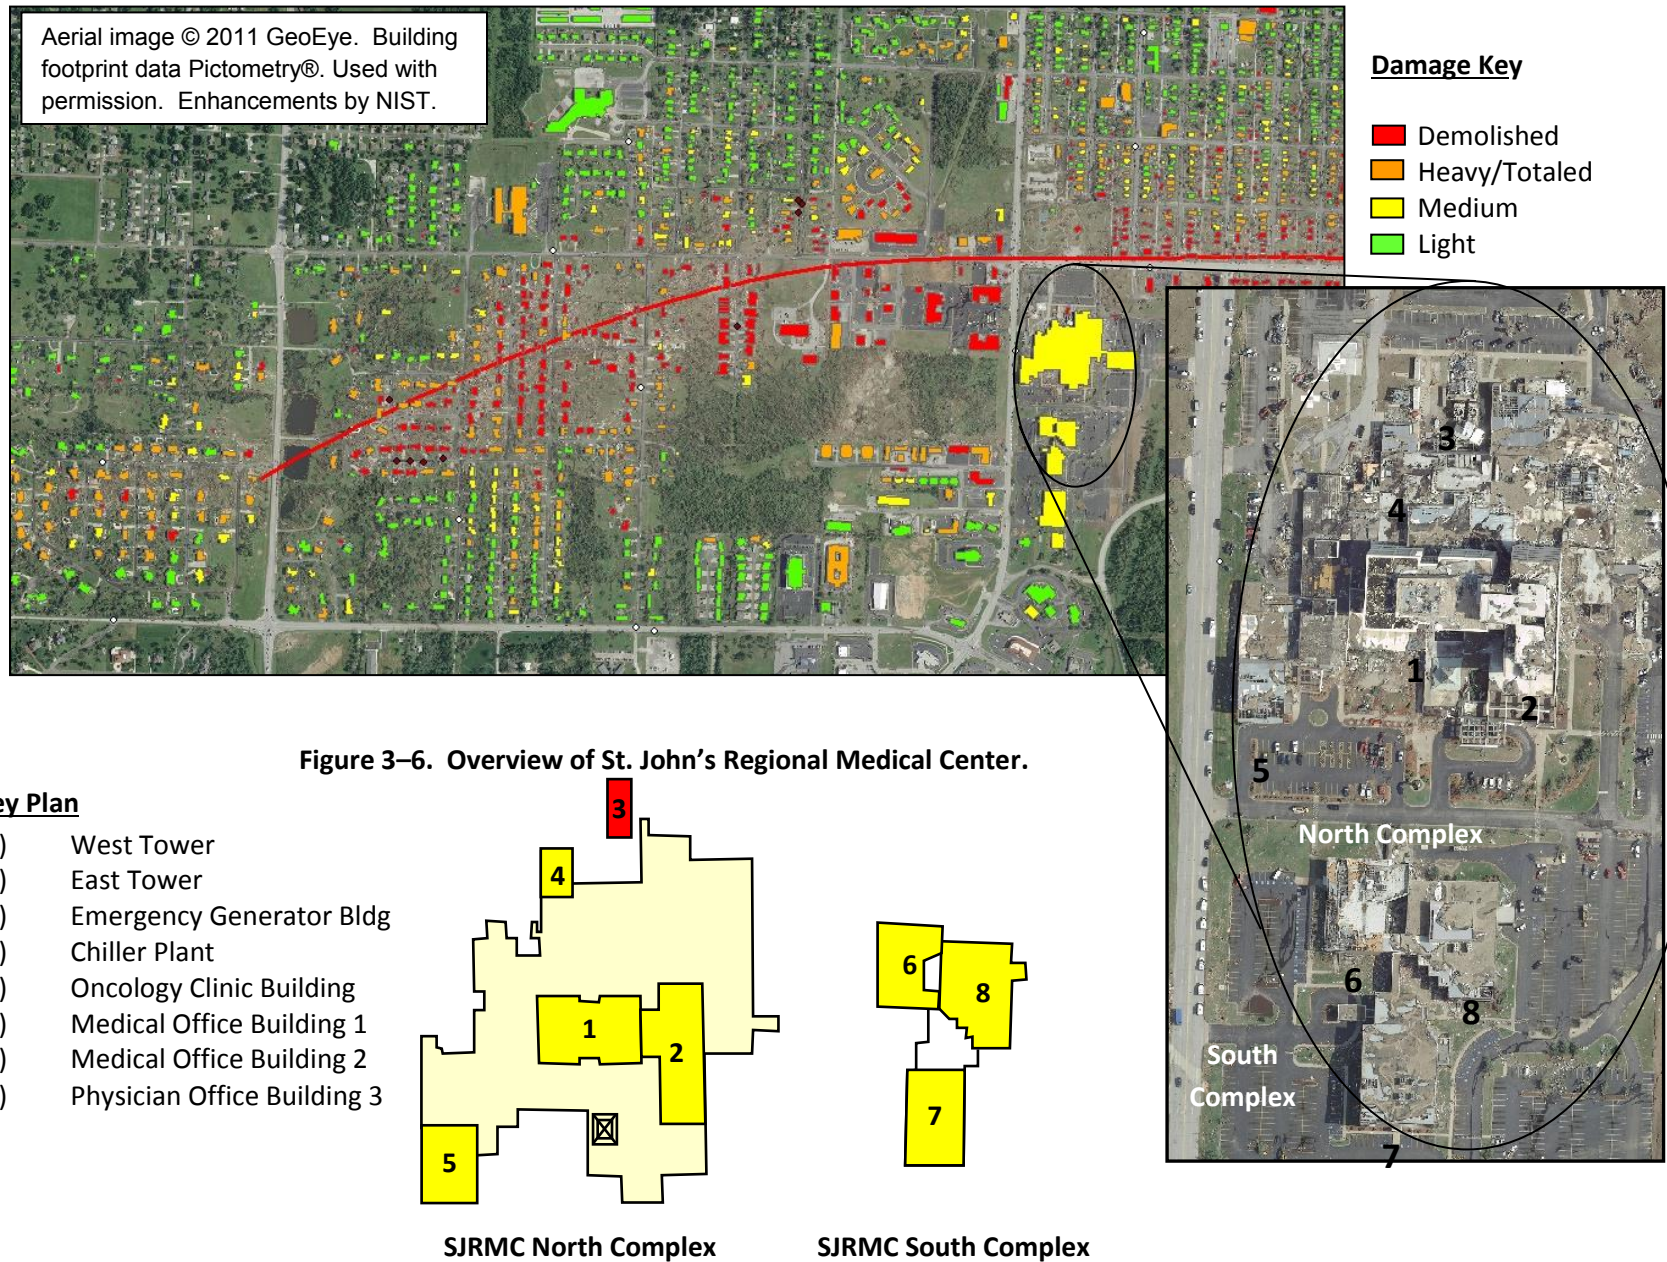
The SJRMC buildings were color-coded on Figure 3-6 based on damage estimates by Pictometry® which showed the Emergency Generator Building as being *demolished* by the tornado and all other SJRMC buildings as having sustained *medium* damage. The Pictometry® database was one of three damage

databases obtained by NIST (the others created by the U.S. Army Corps of Engineers and the SAVE⁸⁰ Coalition). SJRMC was situated immediately to the east of a mixed commercial and residential area in which the majority of buildings were demolished by the tornado (EF-4 damage based on NIST's evaluation). Thus, it was directly downstream of the debris field that resulted from the damage to buildings in this area.

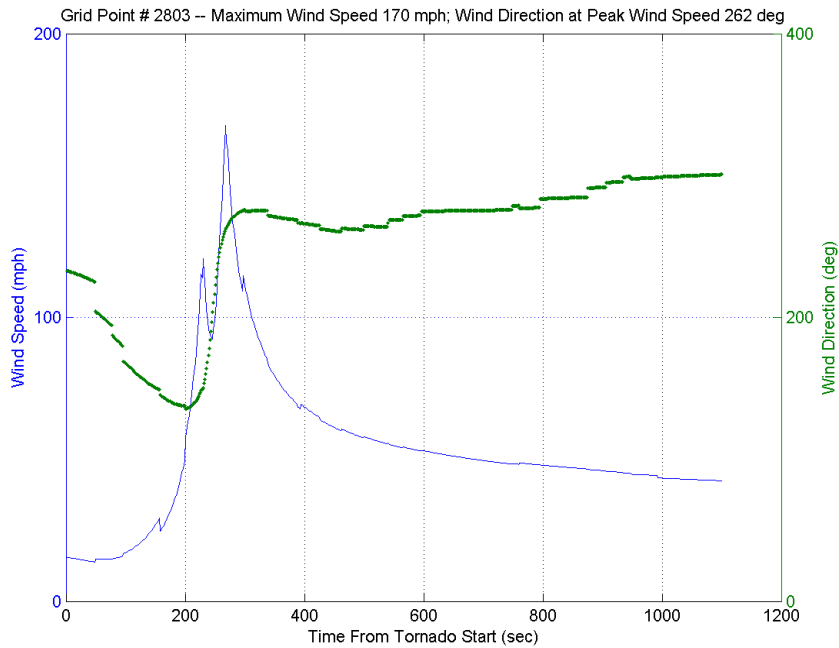
Figures 3-7 and 3-8 show the time histories of wind speed and wind direction estimated for locations close to the north and south complexes of SJRMC. These figures indicate that buildings in the north complex, which were closer to the center line of the tornado damage path, experienced stronger winds than did buildings in the south complex. The maximum wind speed that affected buildings in the north complex was estimated to be about 170 mph \pm 20 mph (EF-4 range, from a westerly direction), and the maximum wind speed affecting the south complex buildings was estimated to be about 120 mph \pm 20 mph (EF-2 to EF-3 range, from a south-westerly direction). Given SJRMC's functionality as a critical facility that should remain operational, current building code would have designated its buildings as Risk Category IV structures for design purposes, meaning that they would have been designed for a basic wind speed of 120 mph based on today's design standards.

Figure 3–7. Time–history of wind speed and direction at north end of SJRMC.

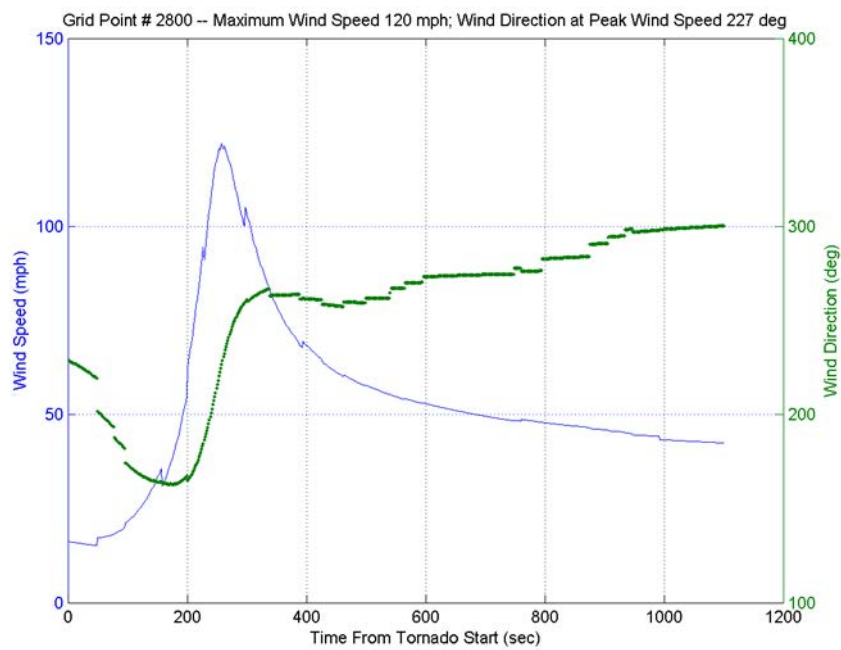
Figure 3–8. Time–history of wind speed and direction at south end of SJRMC.

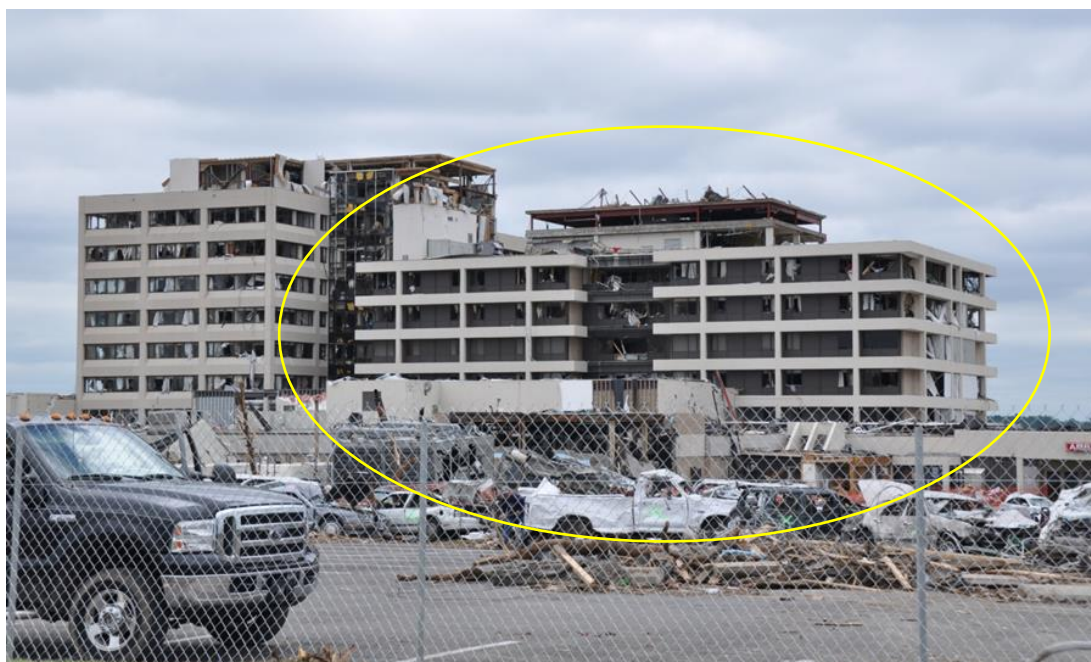
Figure 3–9. SJRMC's West Tower (north side).

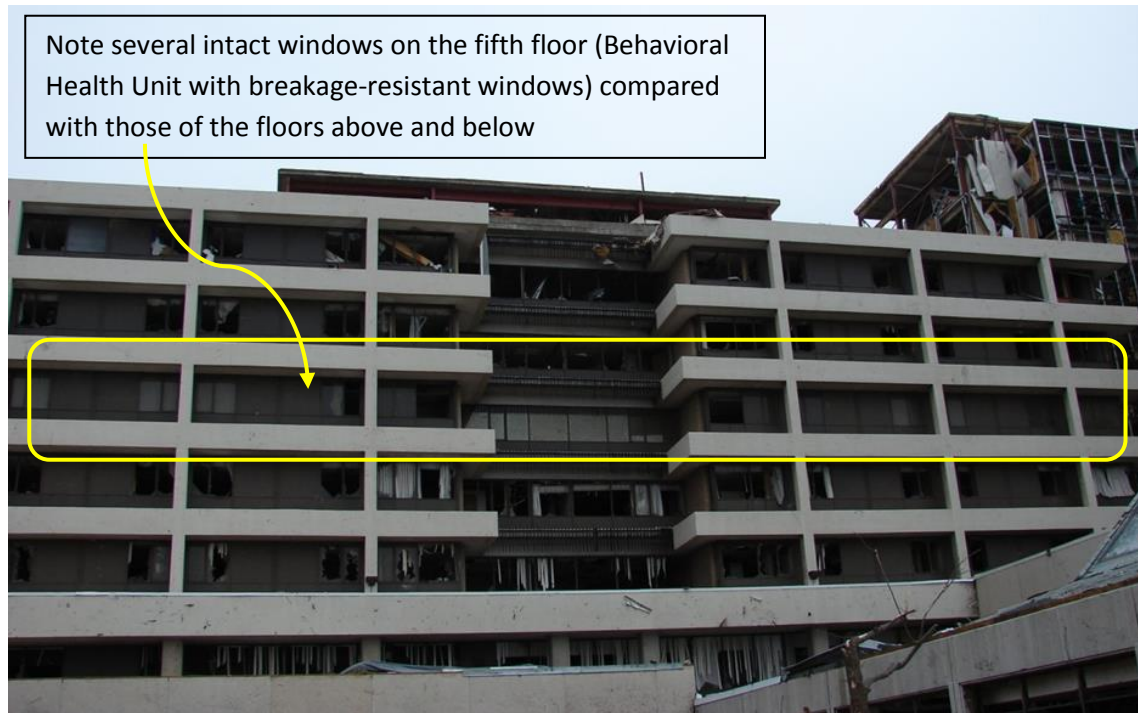
Figure 3–10. Intact windows on fifth floor of West Tower (south side).

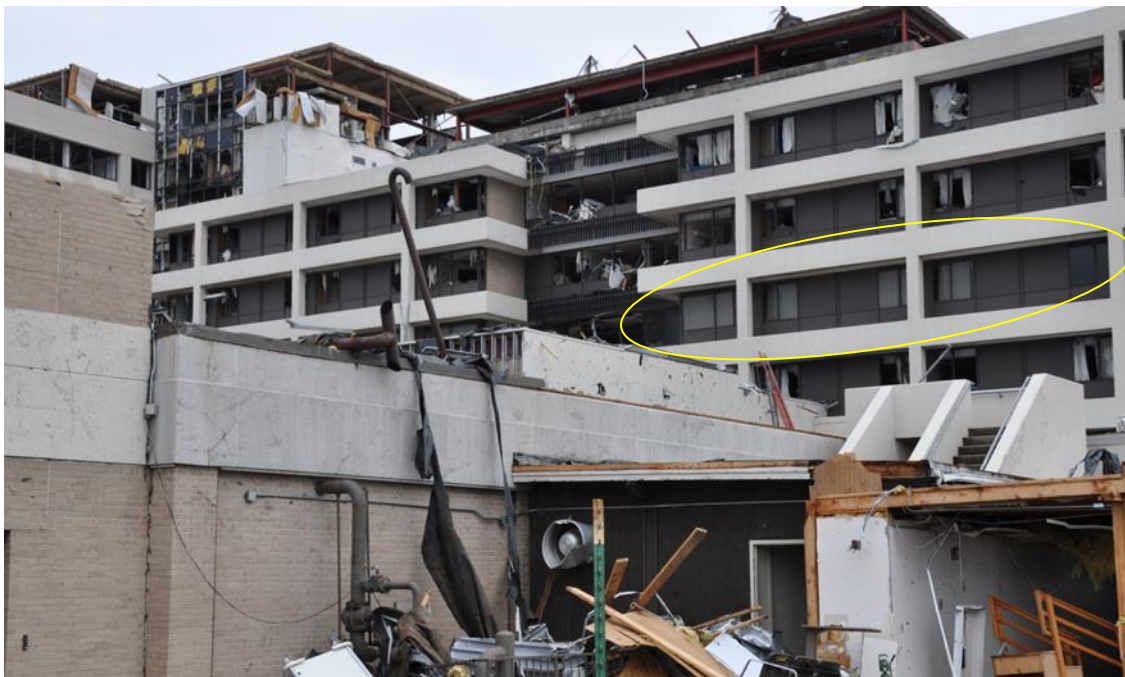
Figure 3–11. Intact windows on fifth floor of West Tower (north side).

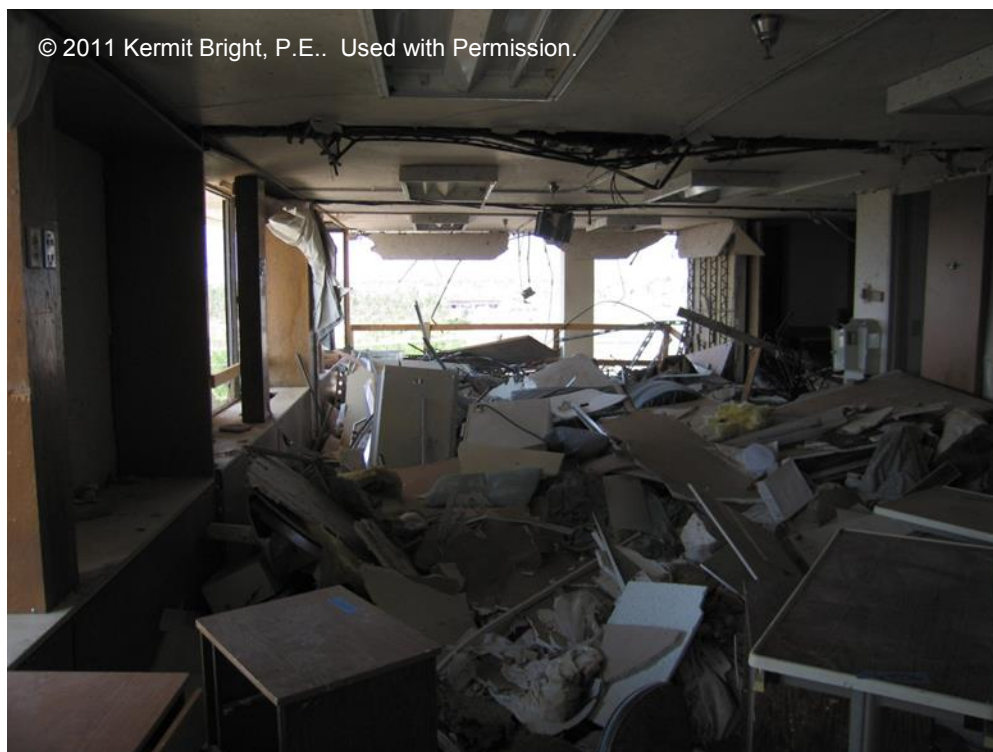
- There was significant damage to the building interior, including:
 - Breakage or collapse of interior partitions, suspended ceiling systems (hanging grid and lay-in ceiling tiles), furniture, electrical fixtures and wiring, HVAC ductwork and equipment, and other general building contents (see Fig. 3–13); and

Figure 3–13. Typical damage to the interior of West Tower.

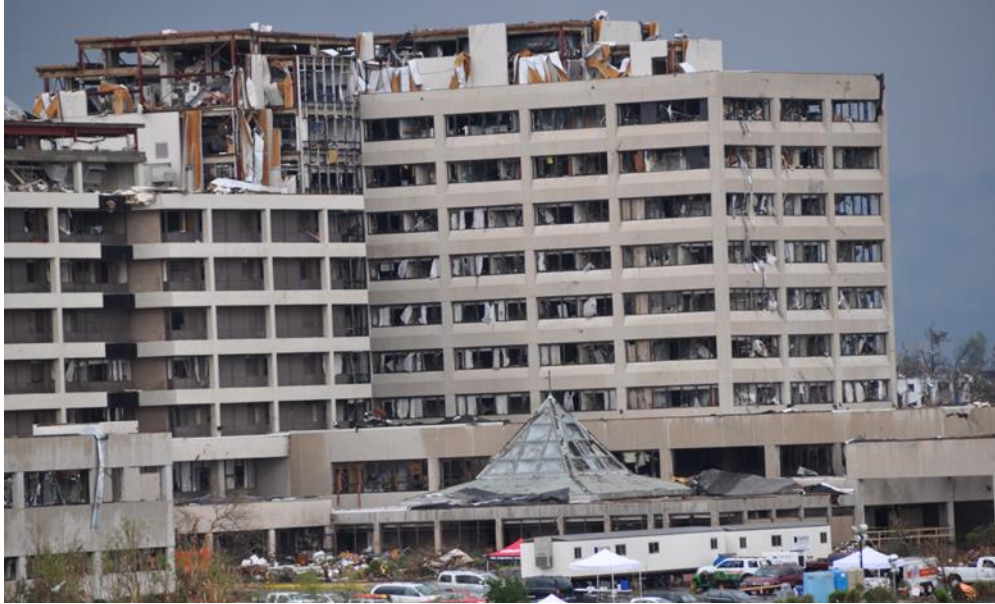
Figure 3–14. View from southwest of East Tower showing that most windows on south and west sides of building and curtain walls on connecting elevator steel frame have broken.

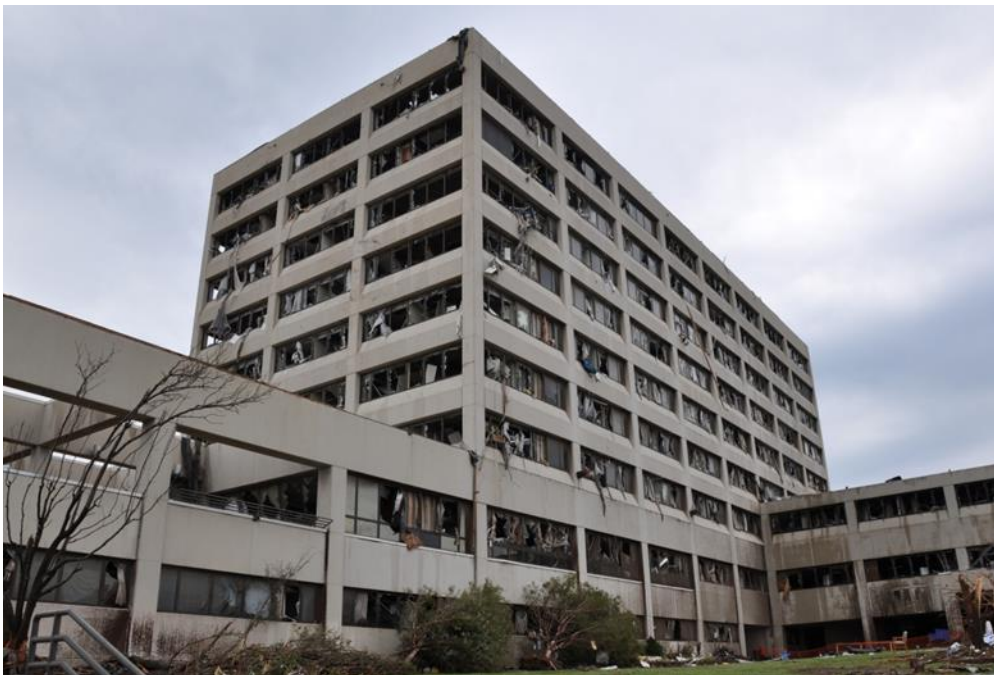
Figure 3–15. View from southeast of East Tower showing that most windows on south and east sides of building have broken.

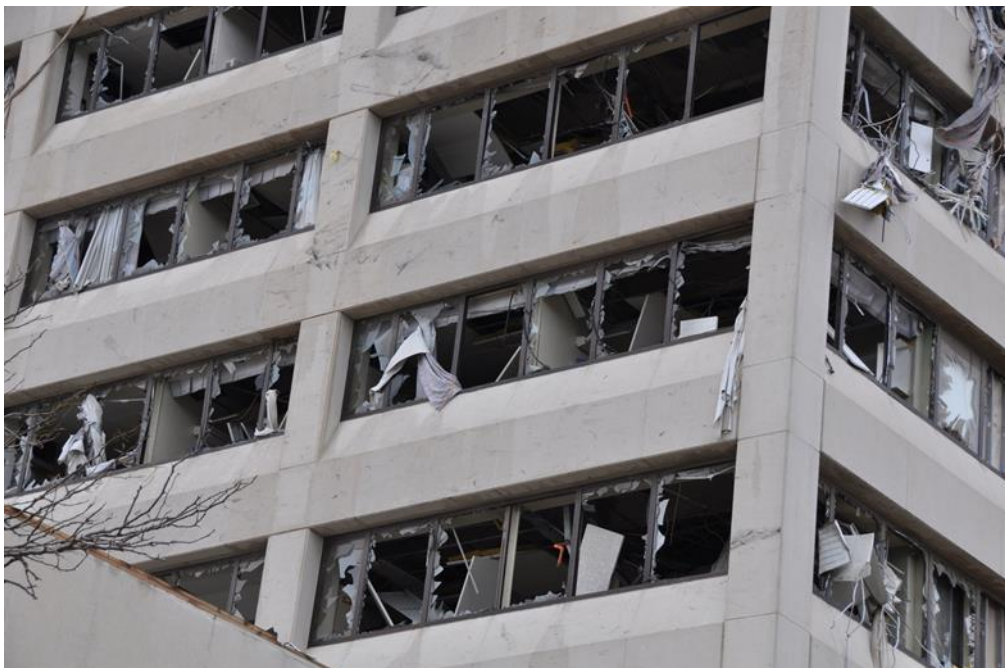
Figure 3–16. Close-up view showing minor damage to architectural precast concrete column-cover-and-spandrel system and significant damage to glass windows of East Tower.
